NEW DELHI, FRIDAY, APRIL 20, 2007/CHAITRA 30, 1929

“17 अक्टूबर, 2003 को मैसर्स सिंगरेनी कोलियरी कम्पनी लिमिटेड की कोयला खानों में हुई बड़ी दुर्घटना, जिसमें 10 लोगों की मृत्यु हुई, के संबंध में जांच अदालत की रिपोर्ट”

जांच न्यायालय का प्रतिवेदन

**S. O. 625(E).**— In pursuance of Section 27 of the Mines Act, 1952(35 of 1952) the Central Government hereby publishes, as Annex to this Notification, the following report submitted to it under Sub-section (4) of Section 24 of the said Act by the Court of Inquiry appointed to hold an inquiry into the causes and circumstances attending the accident which occurred on 17th October, 2003 in the collieries of M/s. Singareni Collieries Company Limited, more particularly in the Godavarikhani No. 8A Incline Mine of Ramagundam Region in District Karimnagar of Andhra Pradesh State.

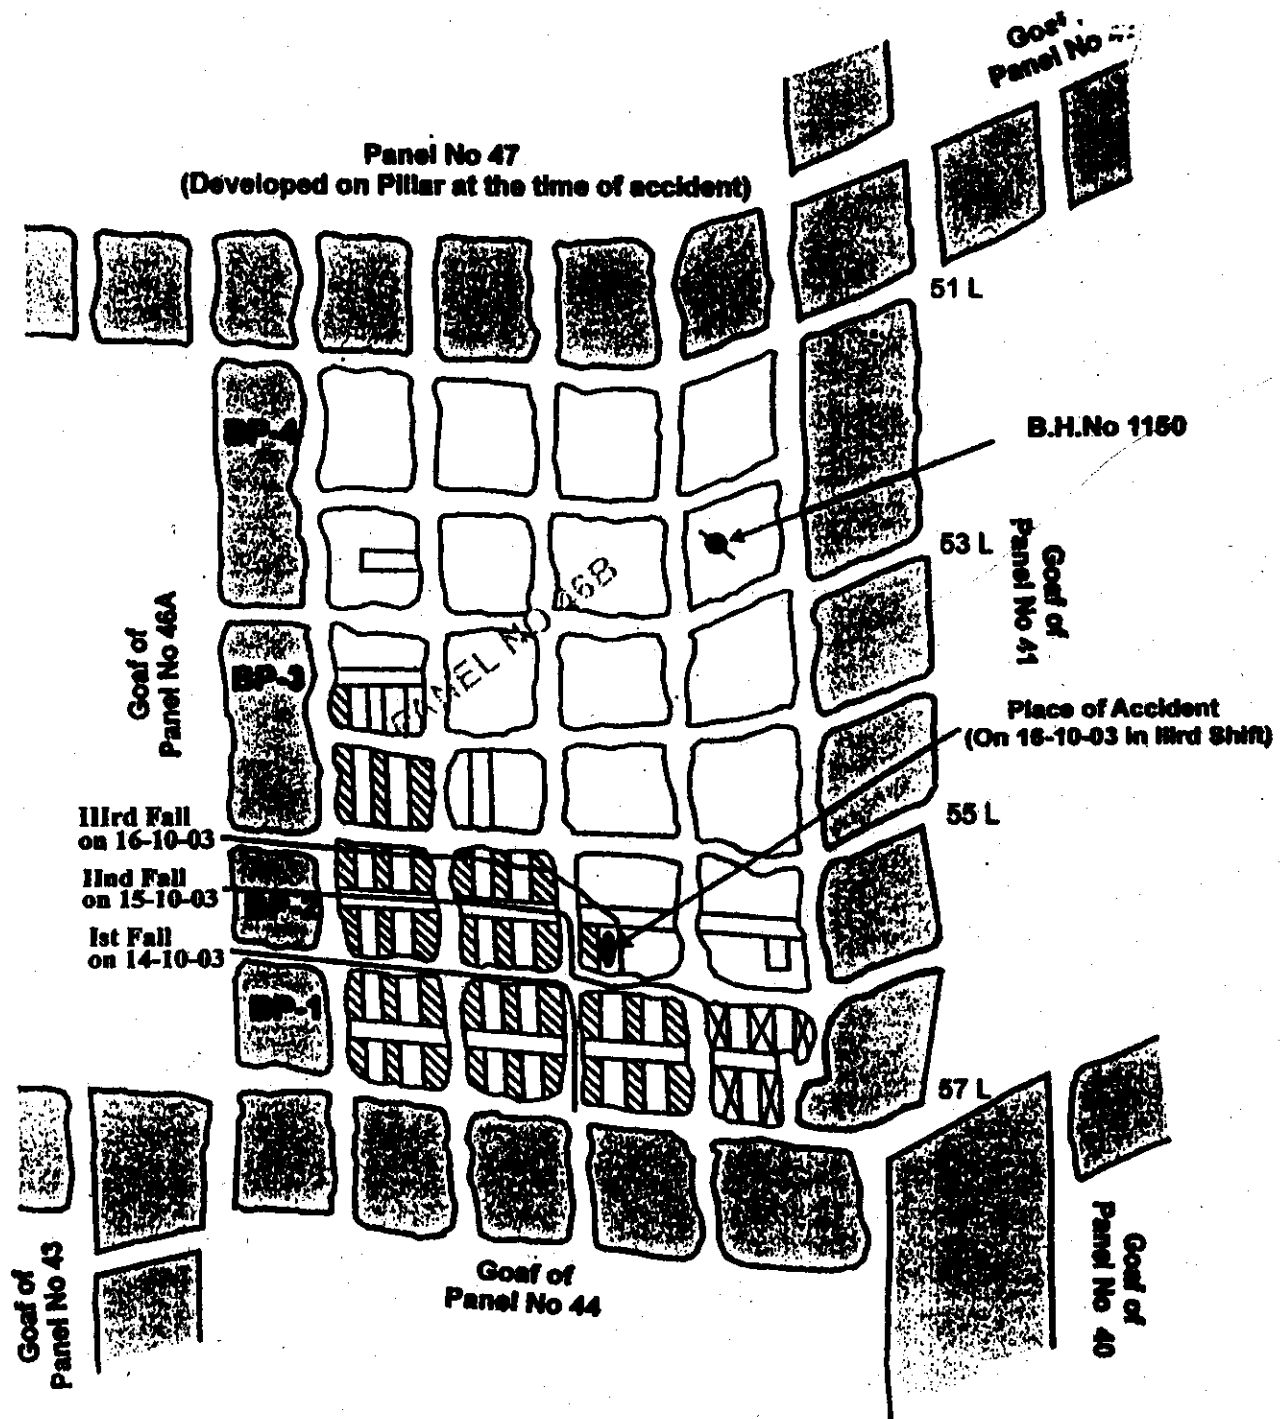
Fig 2: Part plan of the panel no 46B showing line of different falls, Bore Hole position from where rock sample were tested in CMRI laboratory for modelling.

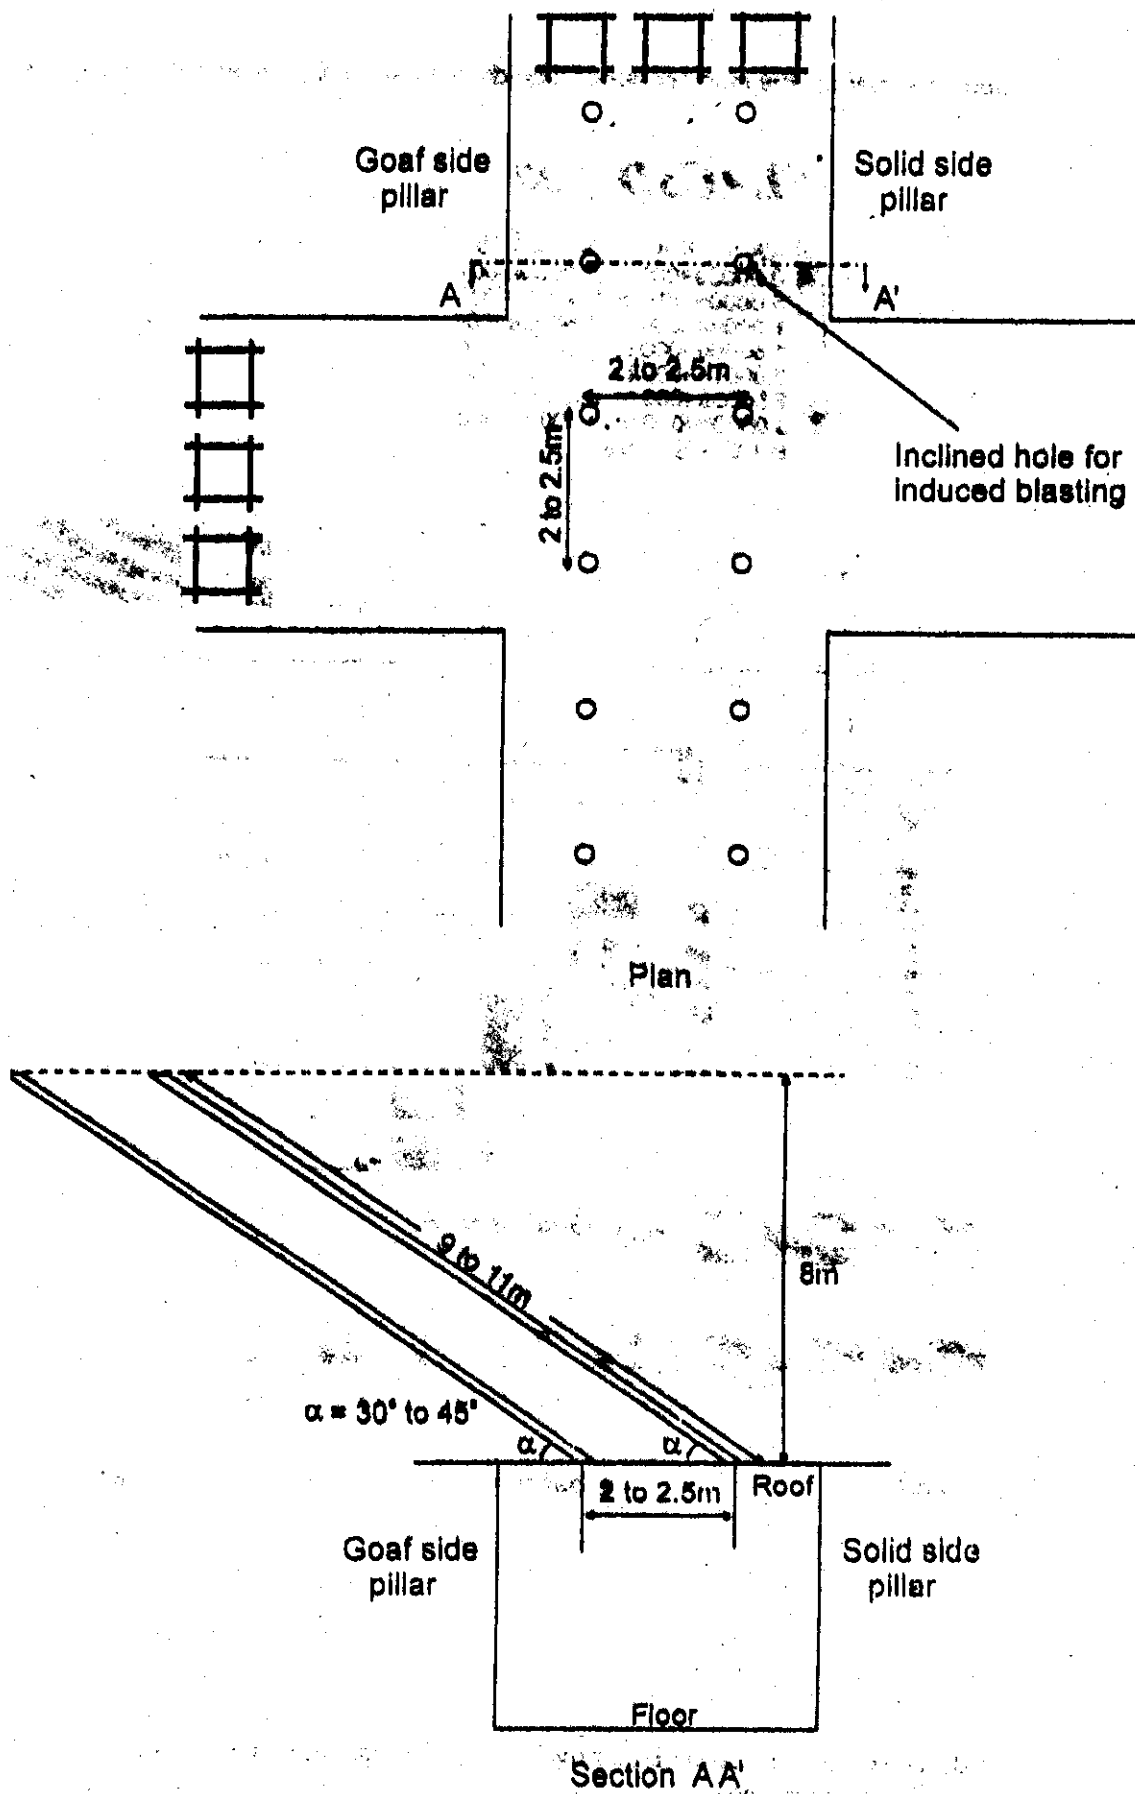
Fig. 9: Goaf edge blasting pattern for induced caving

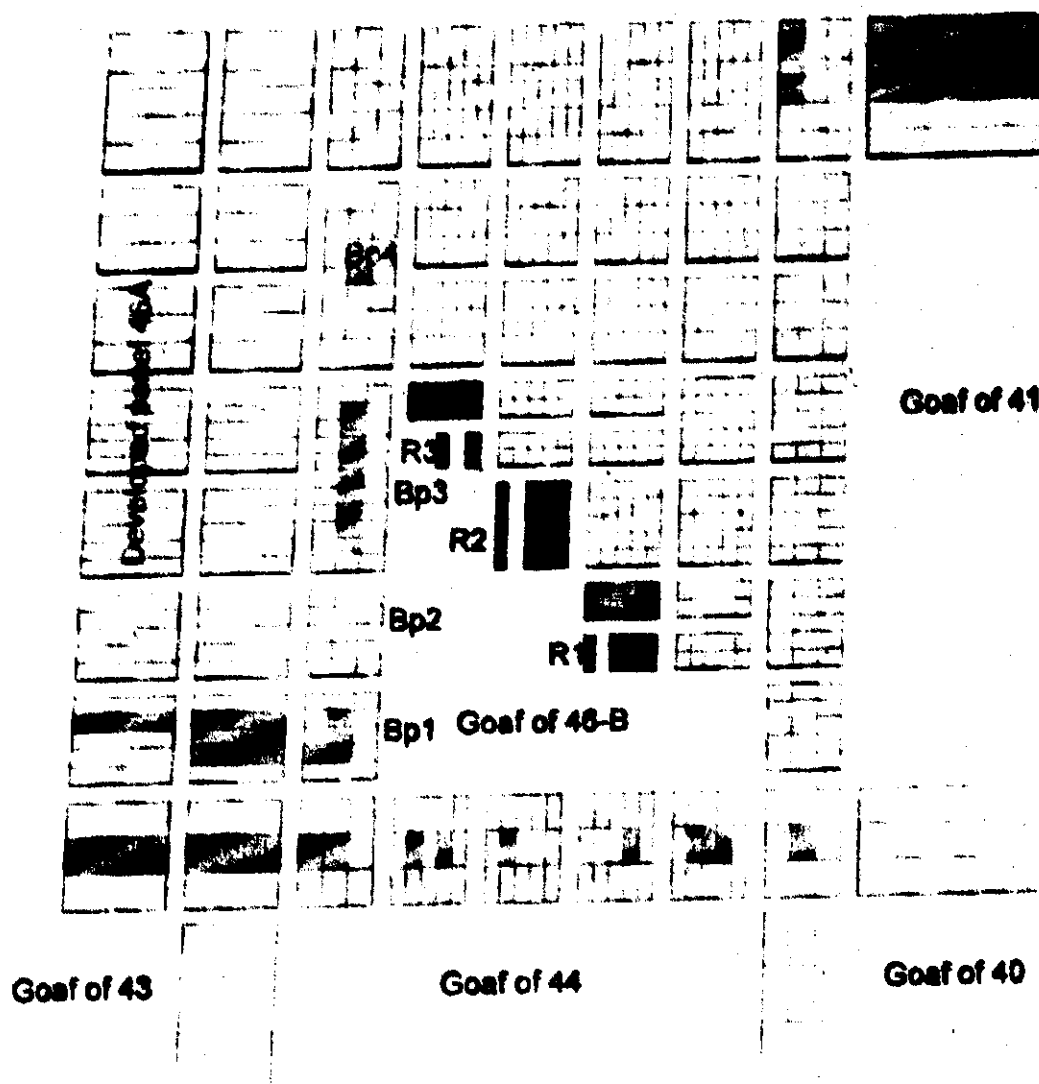
Fig7: Block contours of safety factor over different pillars of panel no 46 B with 46A panel only developed

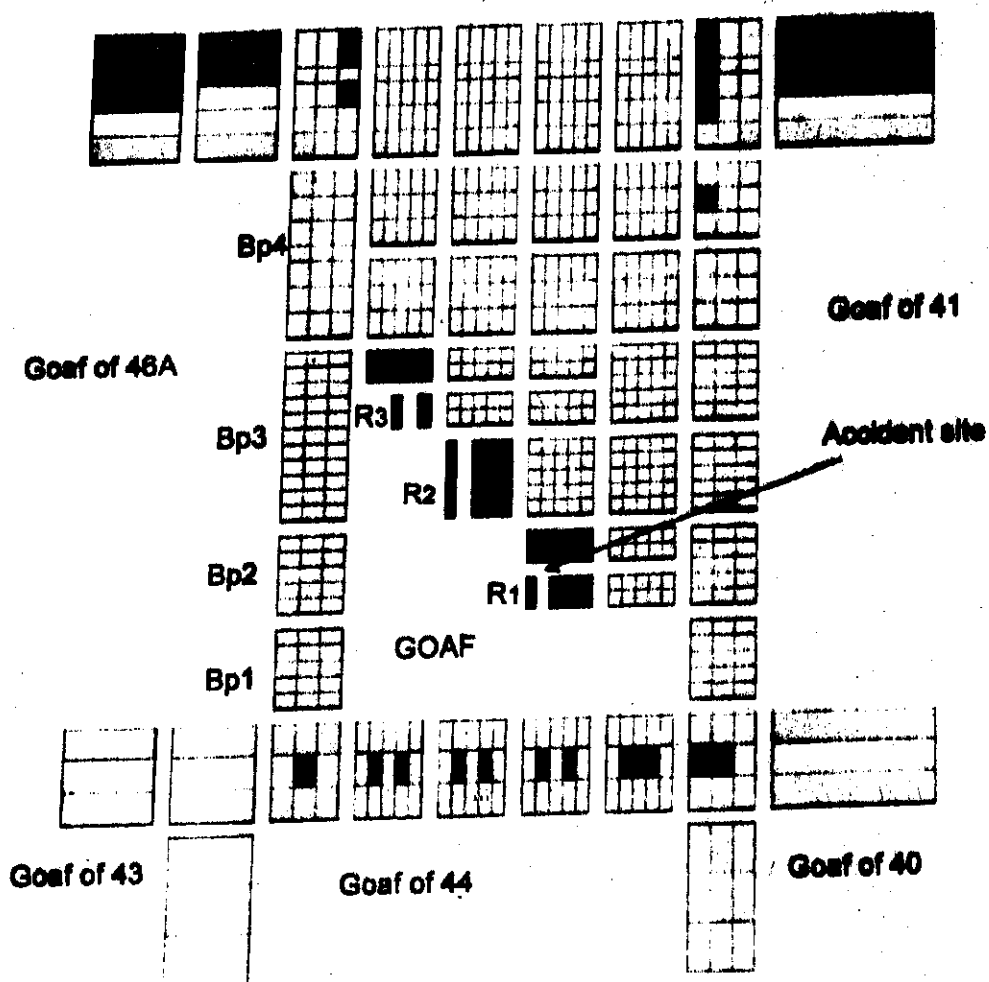
Fig. 6: Block contours of safety factor over the pillars with 3 sides of panel 46-B already extracted

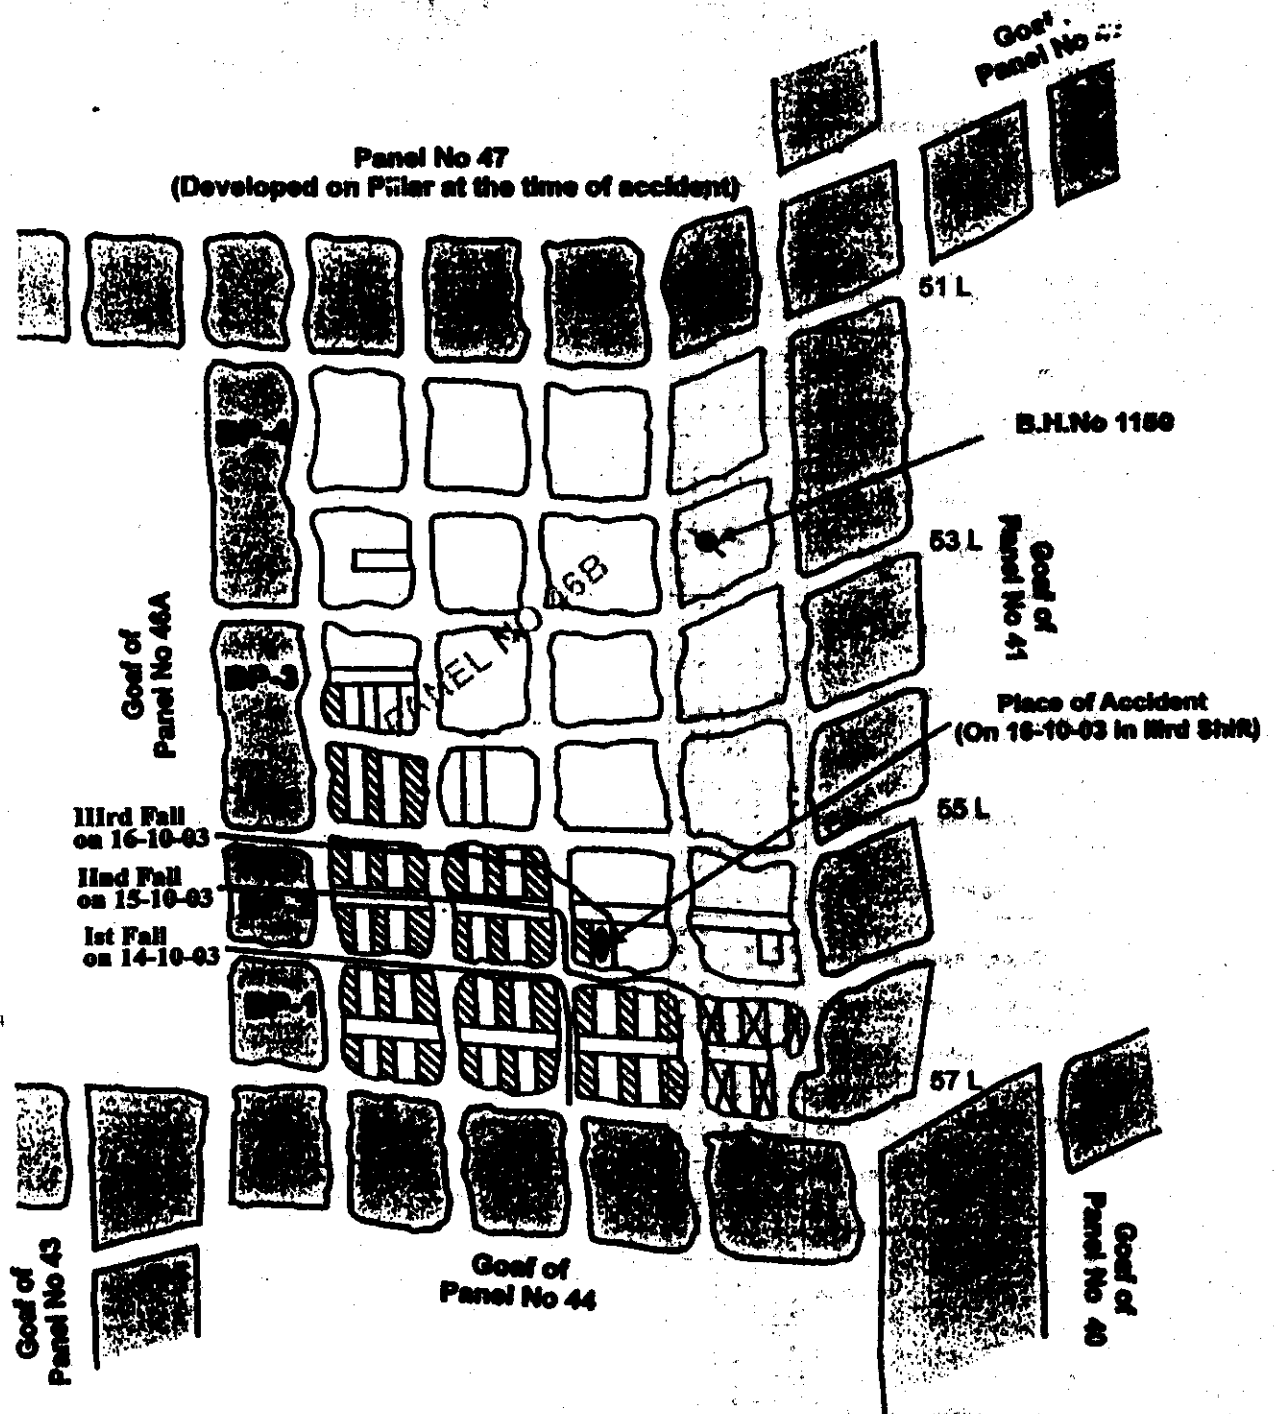
2. At the time of second major fall, half of the barrier pillar BP2 seemed to be crushed. As a result, a line of failure created in the center of barrier pillar BP2 and the second major fall followed.

3. It seems that during third main fall, remaining half of the barrier pillar BP2 was suddenly crushed because its area became almost half of the first one. This might have caused dynamic loading, which overridden the slice, rib and part of the stook.

Fig 2: Part plan of the panel no 46B showing line of different falls. Bore Hole position from where rock sample were tested in CMRI laboratory for modelling.

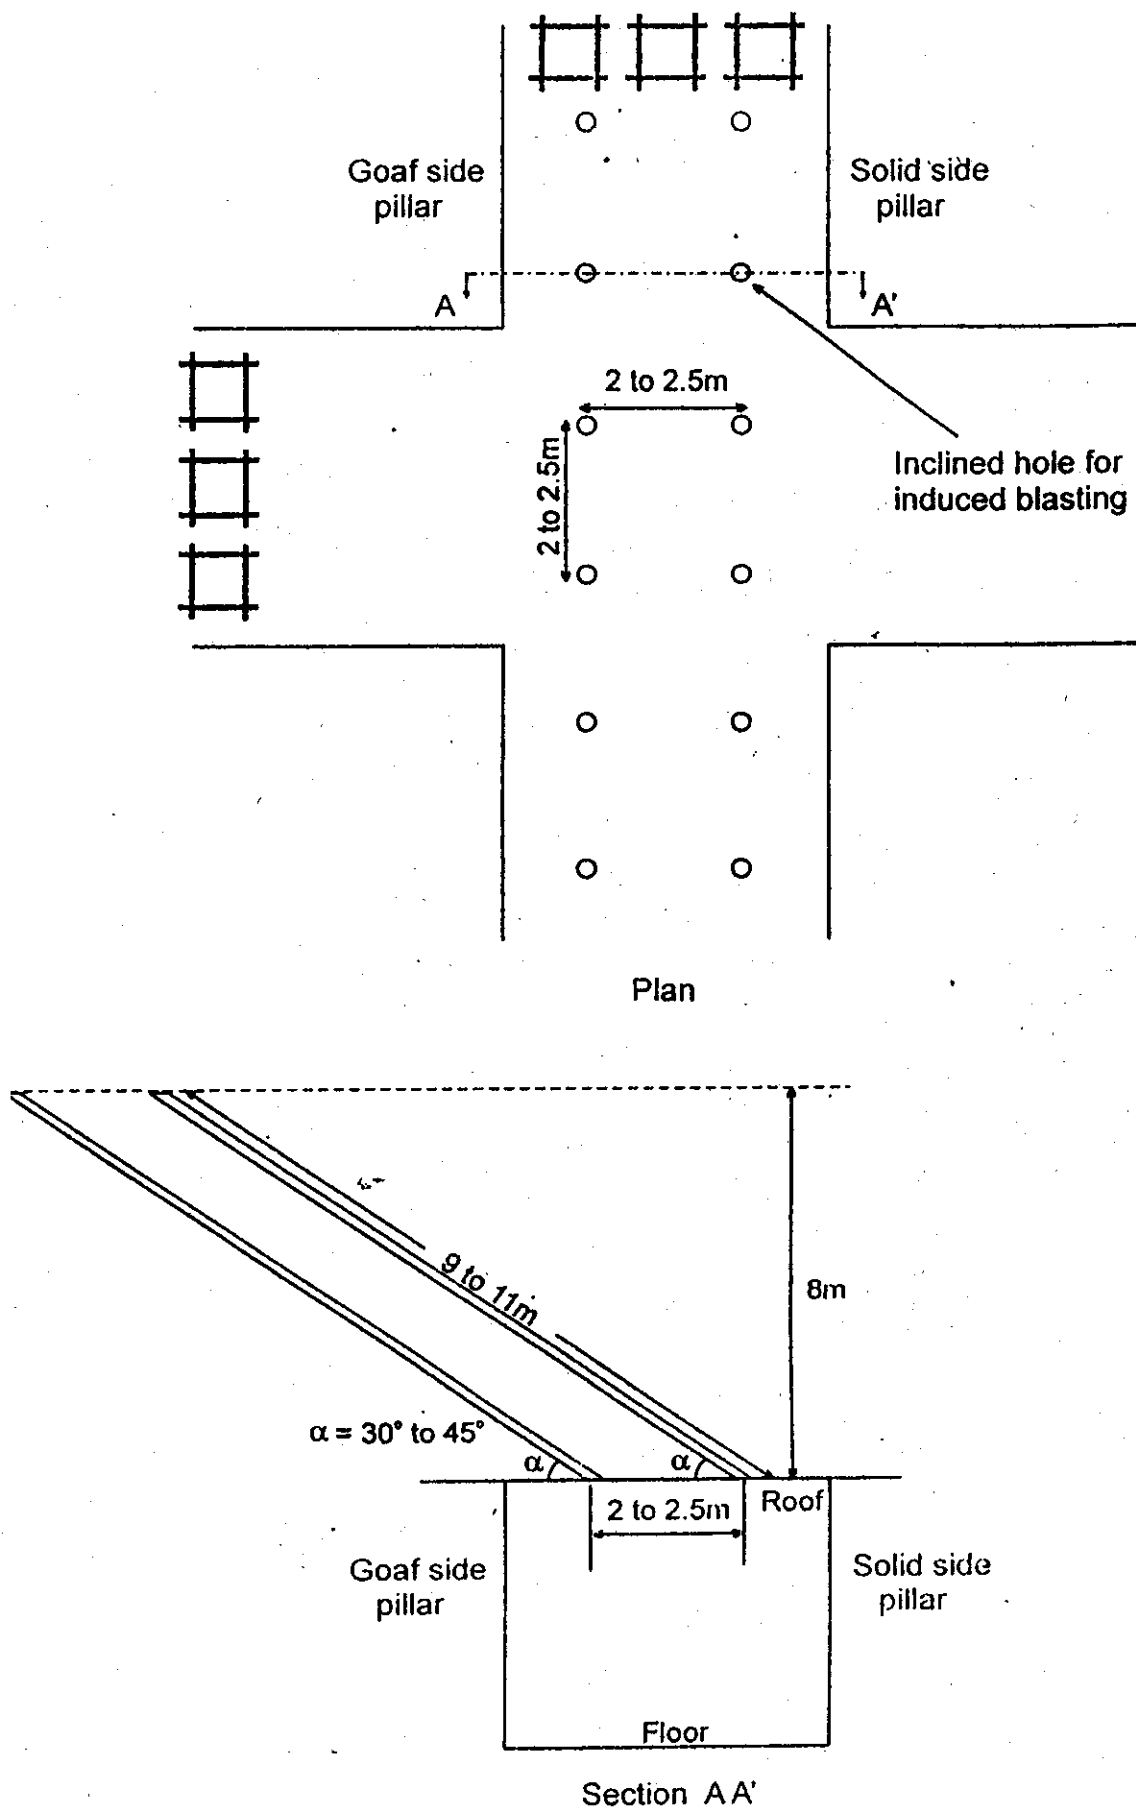
Fig. 9: Goaf edge blasting pattern for induced caving

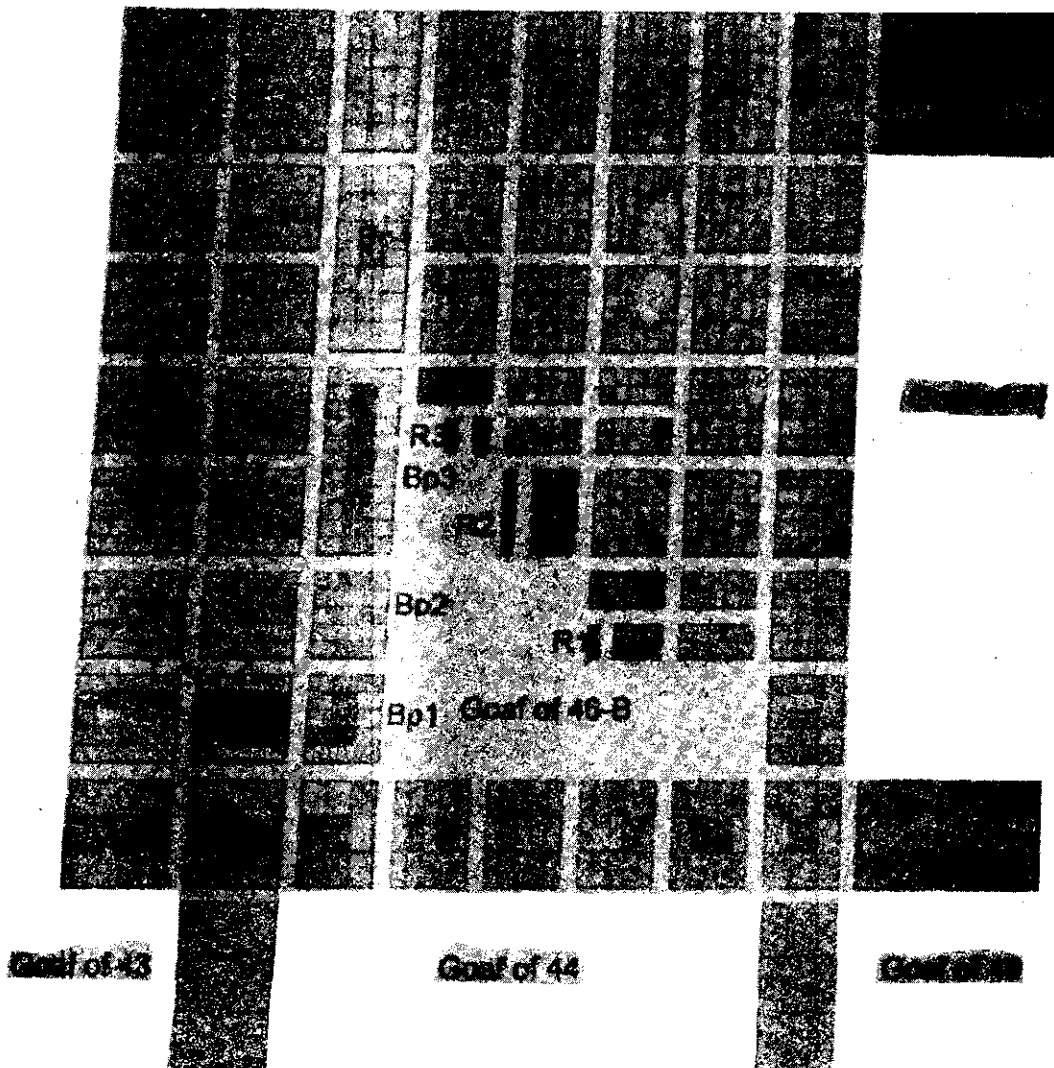
Fig7: Block contours of safety factor over different pillars of panel no 46 B with 46A panel only developed

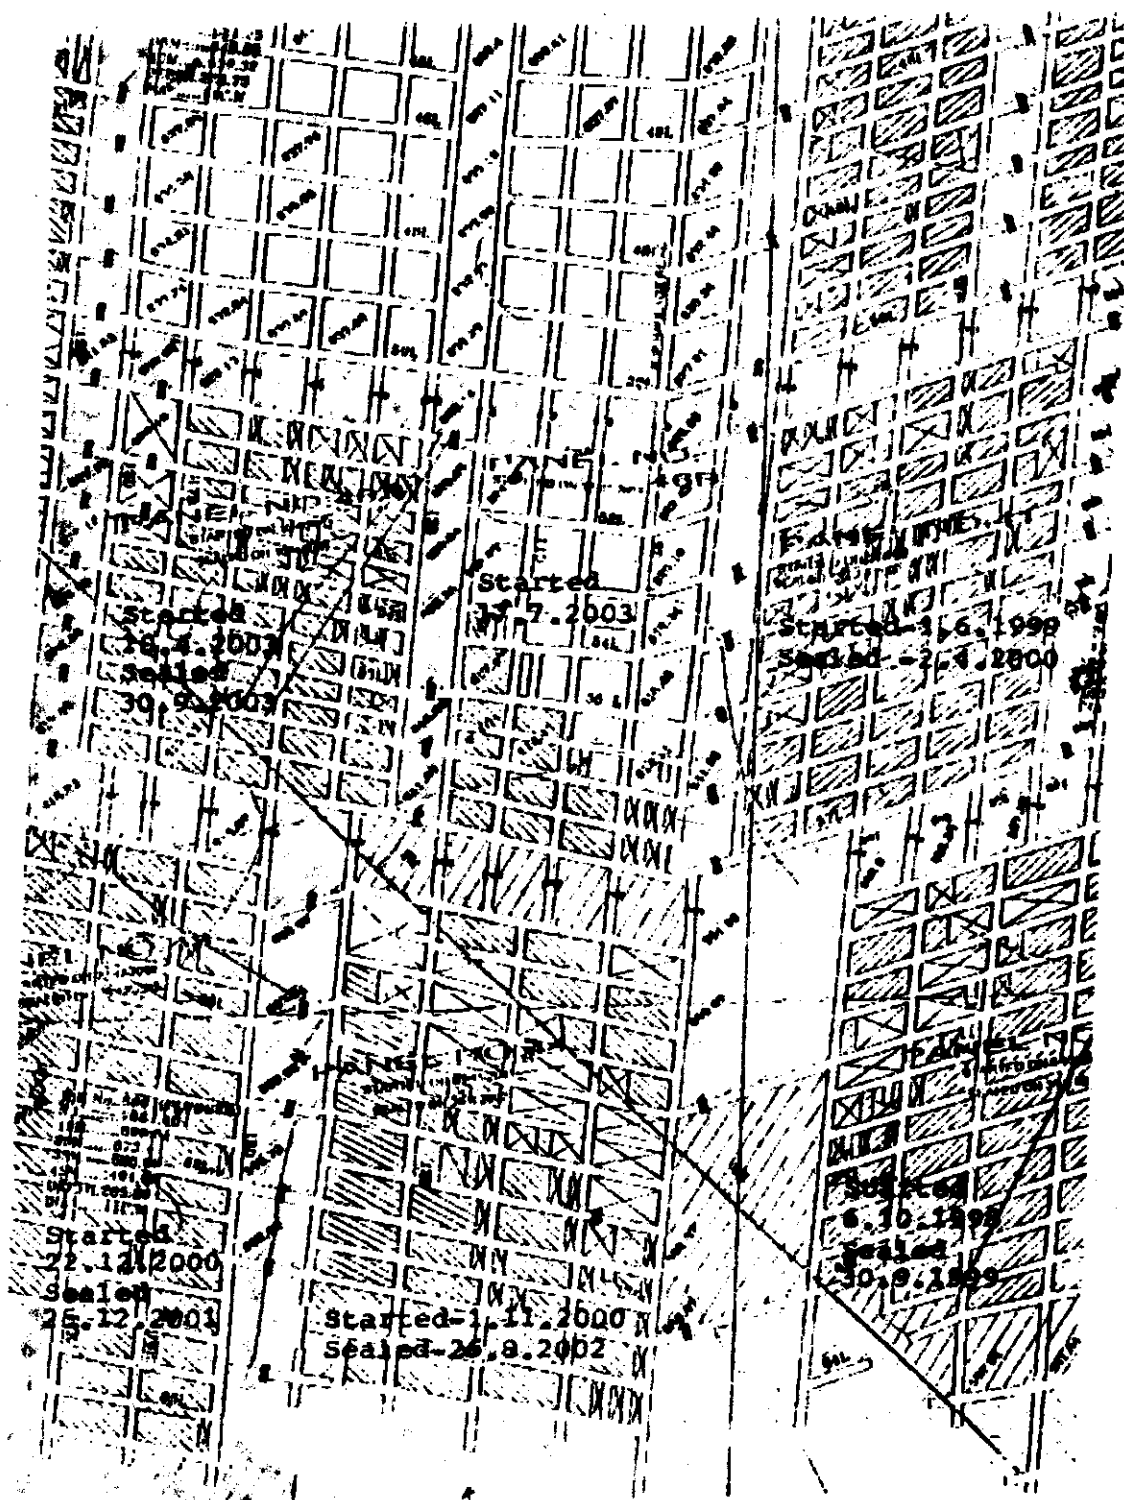
Fig.4 - Working prepositions of different panels  
at the time of accident in Panel No.46B.

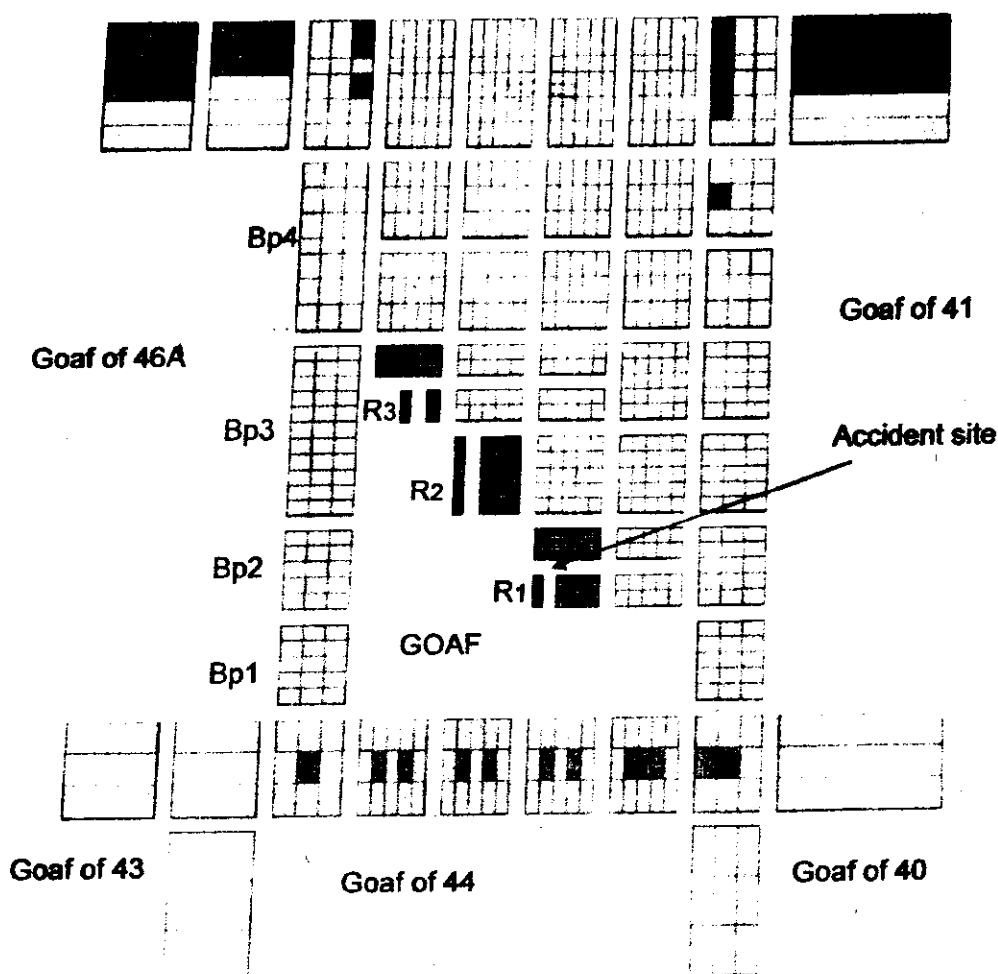
Fig. 6: Block contours of safety factor over the pillars with 3 sides of panel 46-B already extracted
